# Uniform Mitigation Verification Inspection Form

Inspection Date: 24-Sep-14

| Address: 21722 Sound Way | | Home Phone: |

| Inspection Company: <b>Sherlock Home Inspections</b> | Phone: <b>239-292-0756</b> | |

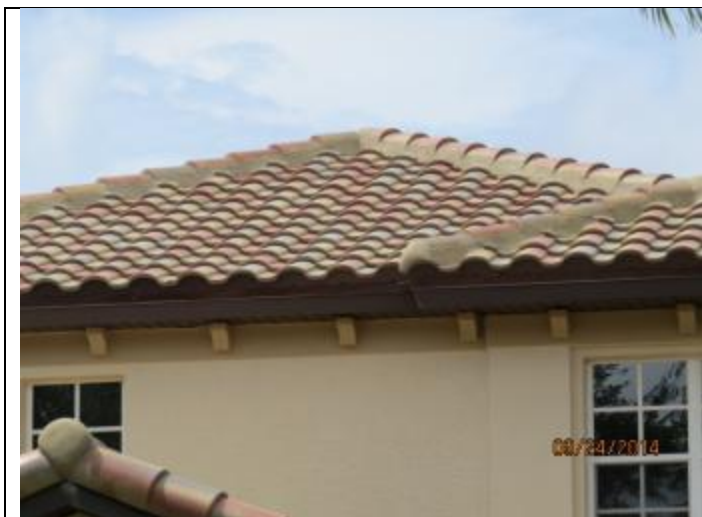
PHOTO 1 – Roof Overview, Covering = Tile

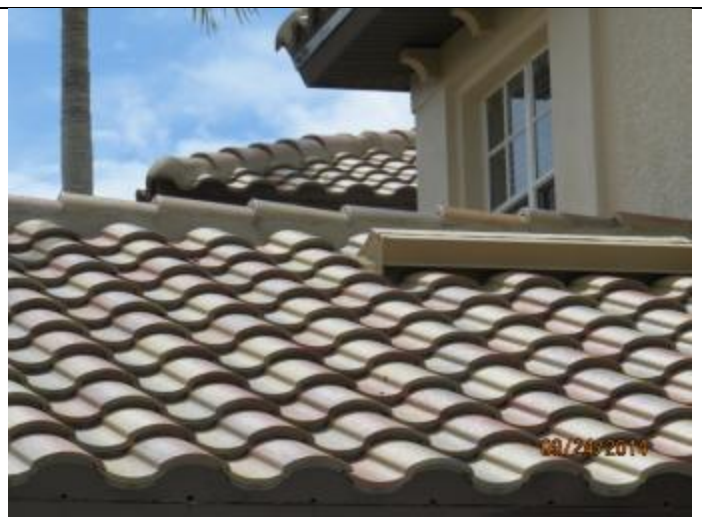
PHOTO 2 – Roof Overview, Covering = Tile

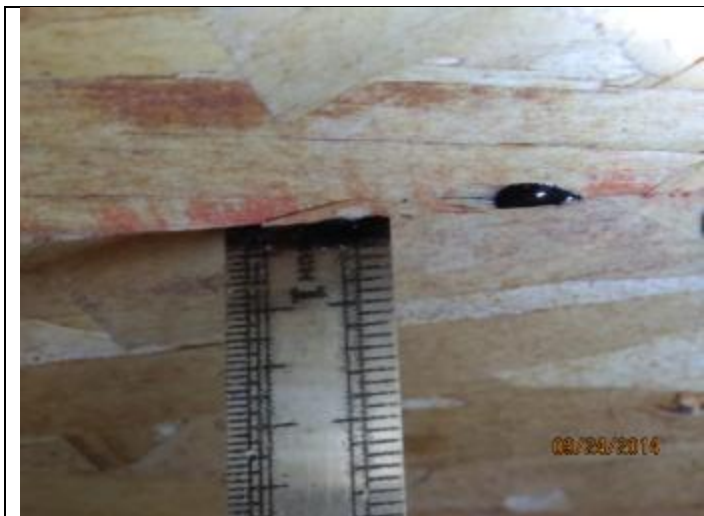
PHOTO 3 – Roof Deck = OSB

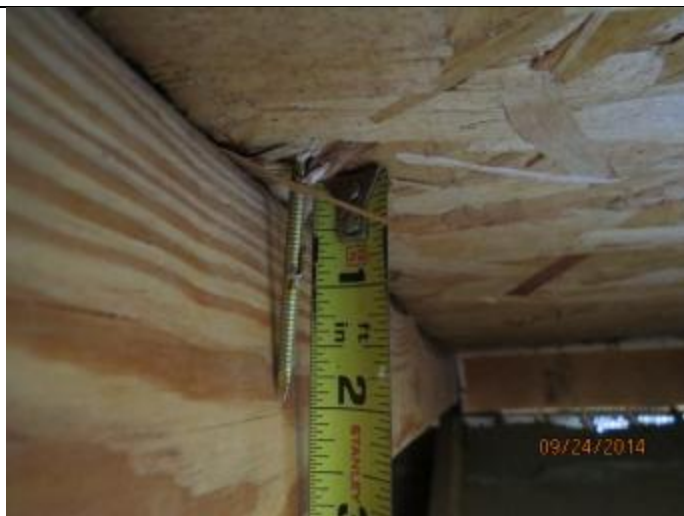
- ☒ C. Plywood/OSB roof sheathing with a minimum thickness of 7/16" inch attached to the roof truss/rafter (spaced a maximum of 24" inches o.c.) by 8d common nails spaced a maximum of 6" inches in the field. **-OR-** Dimensional lumber/Tongue & Groove decking with a minimum of 2 nails per board (or 1 nail per board if each board is equal to or less than 6 inches in width). **-OR-** Any system of screws, nails, adhesives, other deck fastening system or truss/rafter spacing that is shown to have an equivalent

PHOTO 4 – Roof Deck Attachment = 8D Nails

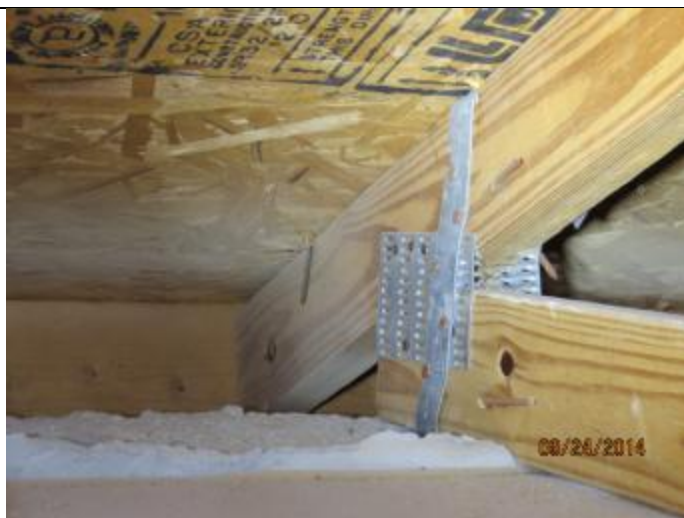
- ☒ C. Single Wraps
  - Metal connectors consisting of a single strap that wraps over the top of the truss/rafter and is secured with a minimum of 2 nails on the front side and a minimum of 1 nail on the opposing side.

PHOTO 8 – Roof To Wall Attachment = Single Wrap Straps

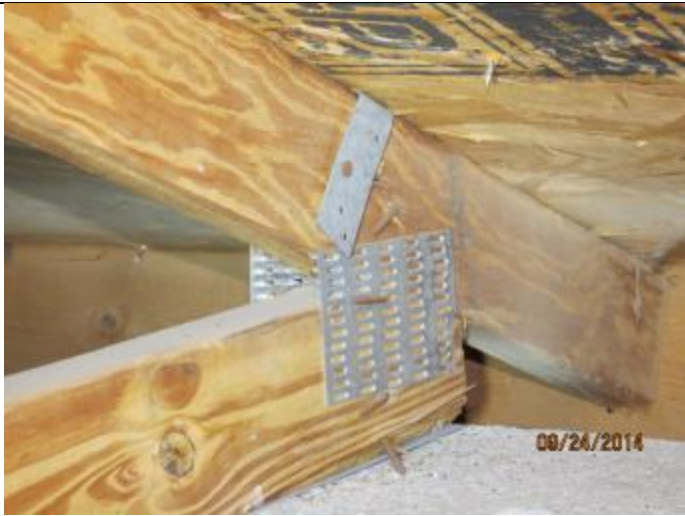
**PHOTO 9 – Roof To Wall Attachment = Single Wrap Straps**

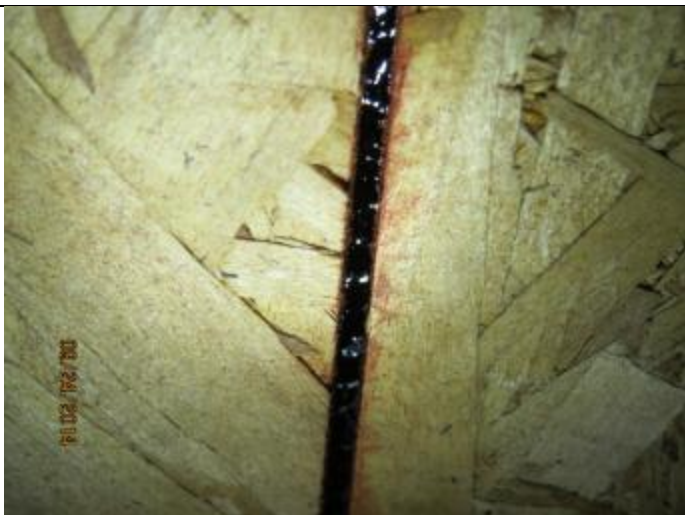
- ☒ A. SWR (also called Sealed Roof Deck) Self-adhering polymer modified-bitumen roofing underlayment applied directly to the sheathing or foam adhesive SWR barrier (not foamed-on insulation) applied as a supplemental means to protect the dwelling from water intrusion in the event of roof covering loss.
- ☐ B. No SWR
- ☐ C. Unknown or undetermined.

**PHOTO 13 - SWR**

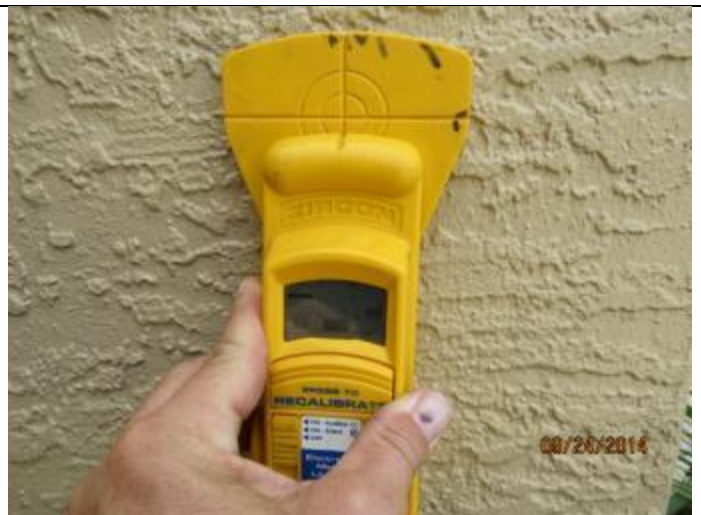
- ☐ A. Wood Frame \_\_\_\_\_ %  
☐ B. Un-Reinforced Masonry \_\_\_\_\_ %  
☒ C. Reinforced Masonry \_\_100\_\_\_\_ %  
☐ D. Poured Concrete \_\_\_\_\_ %  
☐ E. Other: \_\_\_\_\_ %

**PHOTO 14 – Exterior Walls = Reinforced Masonry**
