# Uniform Mitigation Verification Inspection Form

Inspection Date: 24-Sep-14

| Address: 21763 Sound Way | | Home Phone: |

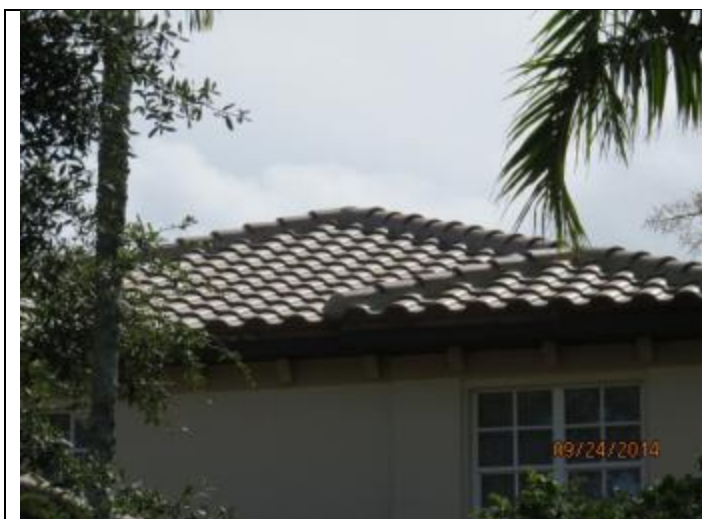
| 2.1 Roof Covering Type | Permit Application Date | FBC or MDC Product Approval # | Year of Original Installation or Replacement | No Information Provided for Compliance |
|---|---|---|---|---|
| <input checked="" type="checkbox"/> 2. Concrete / Clay Tile | 5 / 14 / 2014 | _____ | _____ | <input type="checkbox"/> |

PHOTO 1 – Roof Overview, Covering = Tile

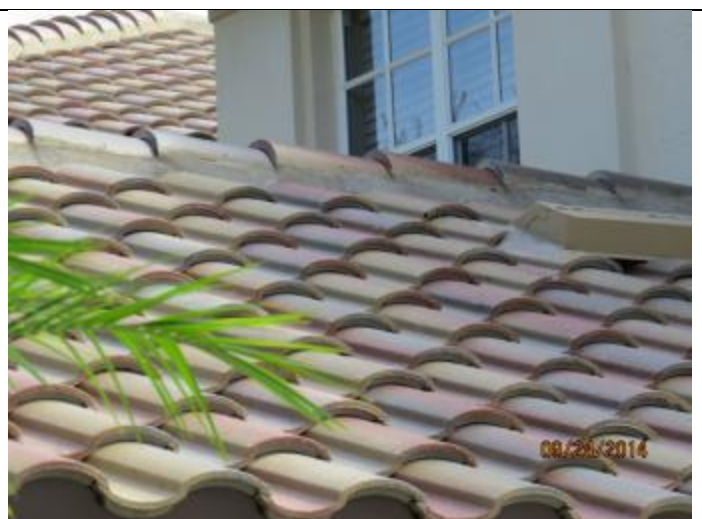
PHOTO 2 – Roof Overview, Covering = Tile

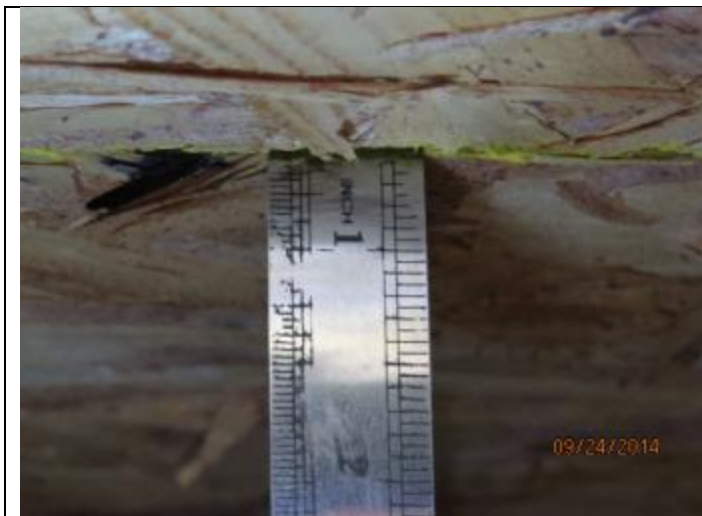
PHOTO 3 – Roof Deck = OSB

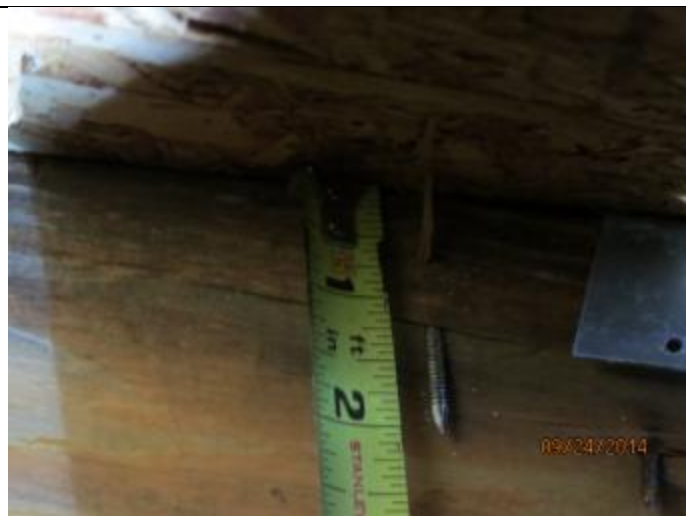
- ☒ C. Plywood/OSB roof sheathing with a minimum thickness of 7/16" inch attached to the roof truss/rafter (spaced a maximum of 24" inches o.c.) by 8d common nails spaced a maximum of 6" inches in the field. **-OR-** Dimensional lumber/Tongue & Groove decking with a minimum of 2 nails per board (or 1 nail per board if each board is equal to or less than 6 inches in width). **-OR-** Any system of screws, nails, adhesives, other deck fastening system or truss/rafter spacing that is shown to have an equivalent

PHOTO 4 – Roof Deck Attachment = 8D Nails

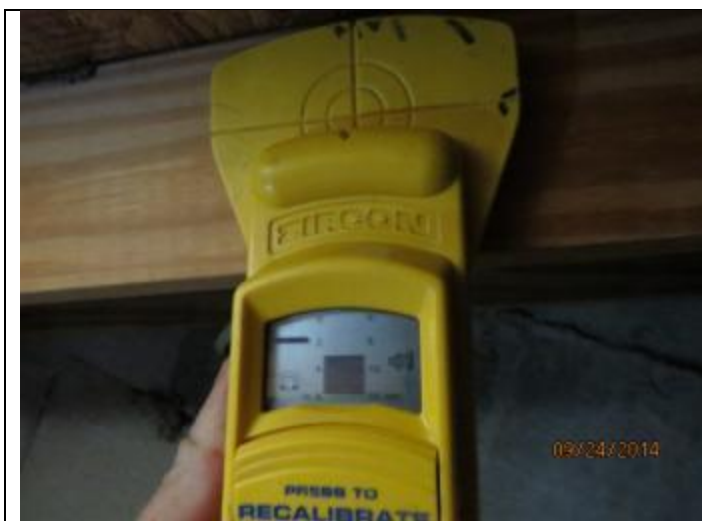
PHOTO 5 – Roof Deck Attachment Locations

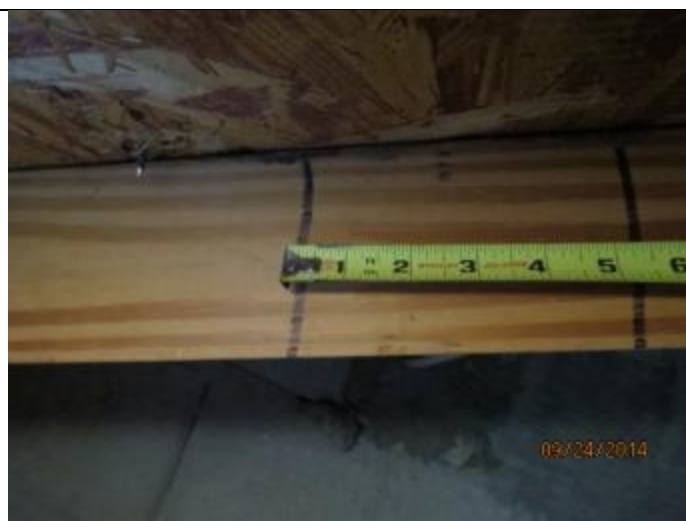
PHOTO 6 – Roof Deck Attachment Spacing

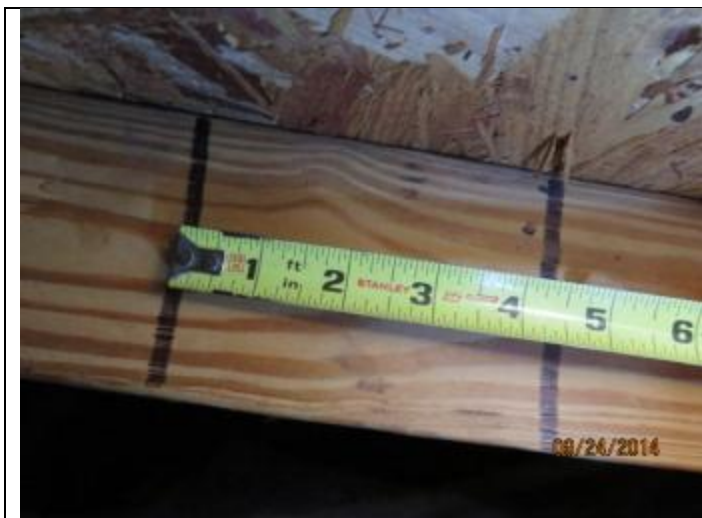
PHOTO 7 – Roof Deck Attachment Spacing

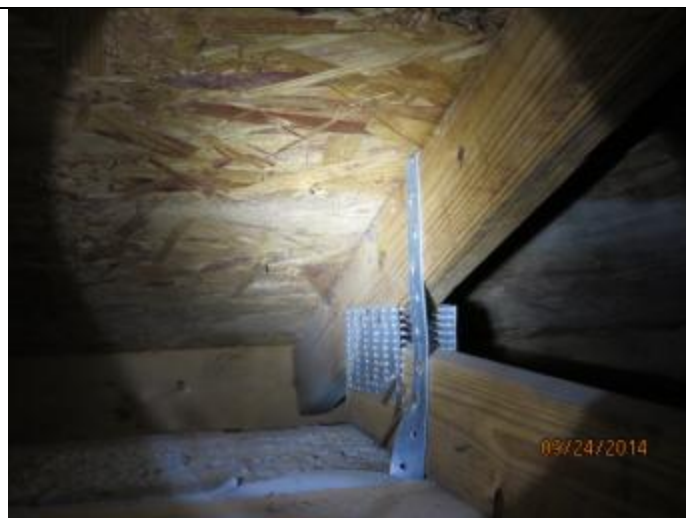
- ☒ B. Clips
  - ☐ Metal connectors that do not wrap over the top of the truss/rafter, or
  - ☒ Metal connectors with a minimum of 1 strap that wraps over the top of the truss/rafter and does not meet the nail position requirements of C or D, but is secured with a minimum of 3 nails.

PHOTO 8 – Roof To Wall Attachment = Clips

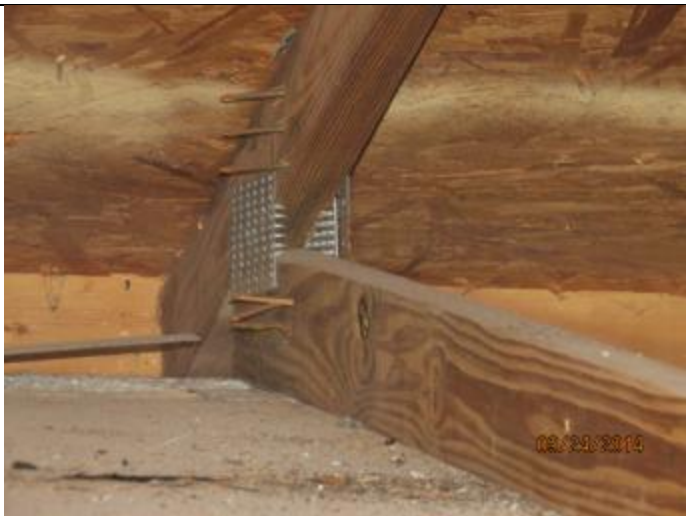
**PHOTO 9 – Roof To Wall Attachment = Clips**

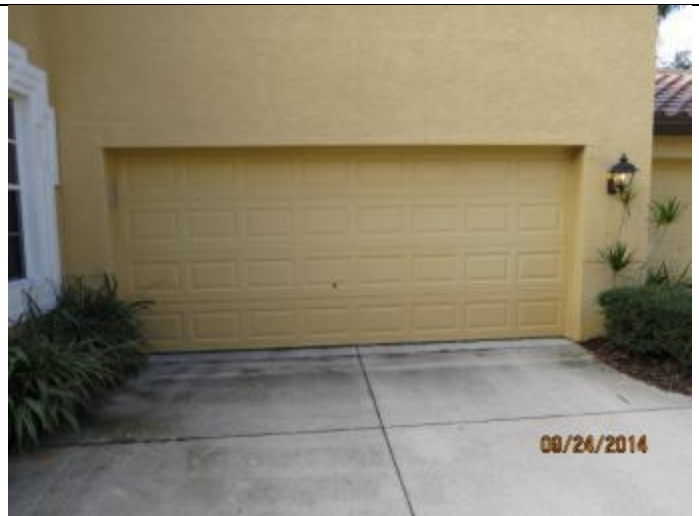
| Opening Protection Level Chart<br>Place an "X" in each row to identify all forms of protection in use for each opening type. Check only one answer below (A thru X), based on the weakest form of protection (lowest row) for any of the Glazed openings and indicate the weakest form of protection (lowest row) for Non-Glazed openings. | | Glazed Openings | | | | Non-Glazed Openings | |
|---|---|---|---|---|---|---|---|
| <b>X</b> | No Windborne Debris Protection | X | | | | | X |

**PHOTO 10 – Garage Door**

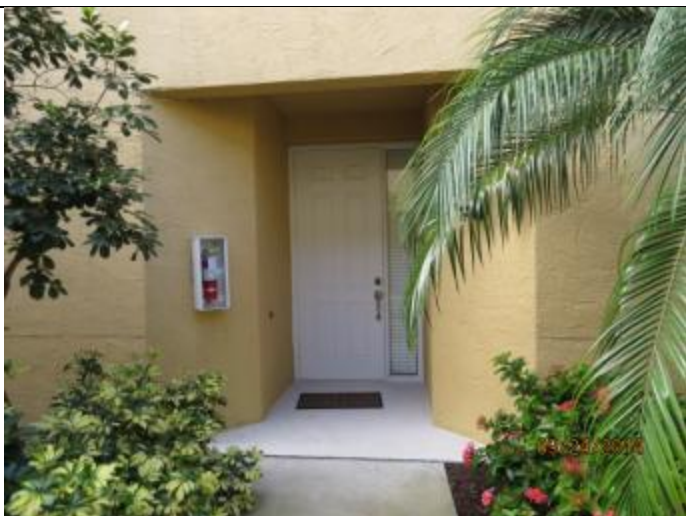
| Opening Protection Level Chart<br>Place an "X" in each row to identify all forms of protection in use for each opening type. Check only one answer below (A thru X), based on the weakest form of protection (lowest row) for any of the Glazed openings and indicate the weakest form of protection (lowest row) for Non-Glazed openings. | | Glazed Openings | | | | Non-Glazed Openings | |
|---|---|---|---|---|---|---|---|
| | Other protective coverings that cannot be identified as A, B, or C | | | | | X | |

**PHOTO 11 – Entry Door**

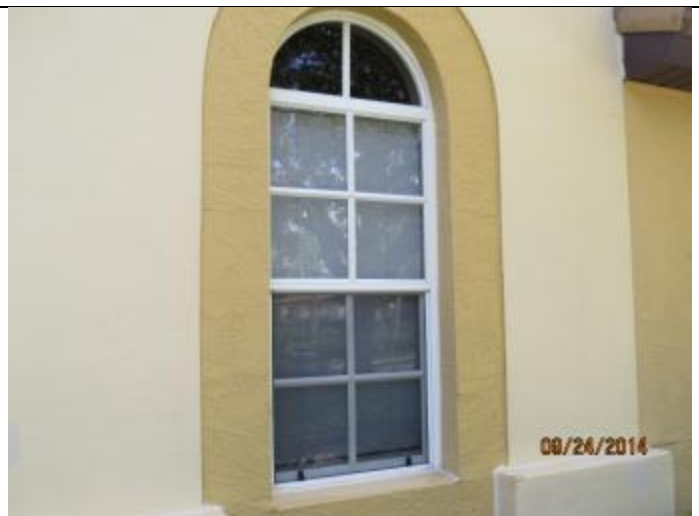
**PHOTO 12 - Window**

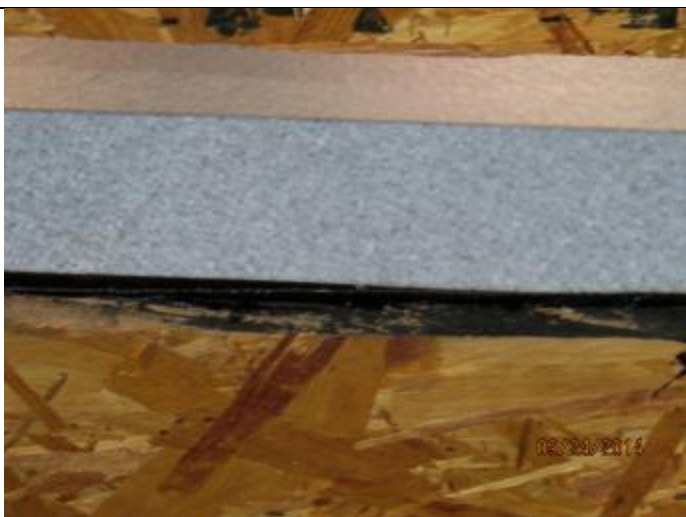
- ☒ A. SWR (also called Sealed Roof Deck) Self-adhering polymer modified-bitumen roofing underlayment applied directly to the sheathing or foam adhesive SWR barrier (not foamed-on insulation) applied as a supplemental means to protect the dwelling from water intrusion in the event of roof covering loss.
- ☐ B. No SWR
- ☐ C. Unknown or undetermined.

**PHOTO 13 - SWR**

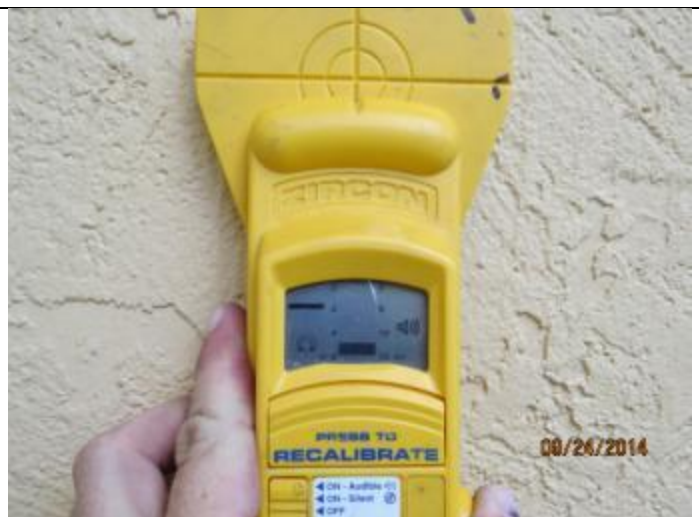
- ☐ A. Wood Frame \_\_\_\_\_ %  
☐ B. Un-Reinforced Masonry \_\_\_\_\_ %  
☒ C. Reinforced Masonry \_\_\_\_100\_\_\_\_ %  
☐ D. Poured Concrete \_\_\_\_\_ %  
☐ E. Other: \_\_\_\_\_ %

**PHOTO 14 – Exterior Walls = Reinforced Masonry**
