# Uniform Mitigation Verification Inspection Form

Inspection Date: 5-Sep-14

| Address: 21775 Sound Way | | Home Phone: |

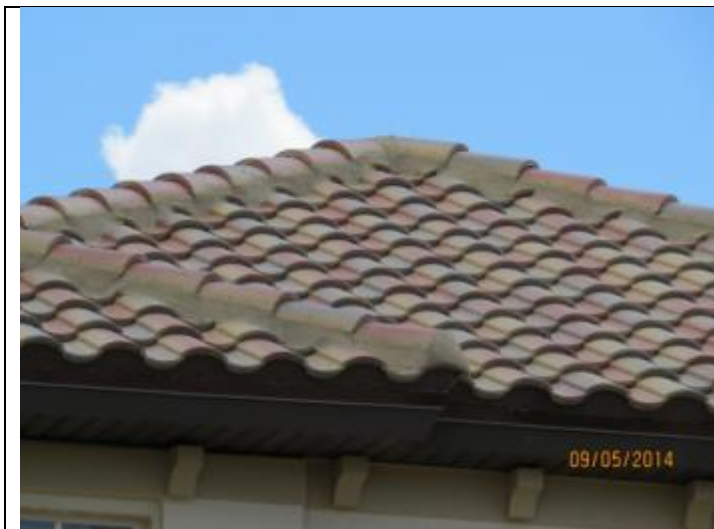
| 2.1 Roof Covering Type | Permit Application Date | FBC or MDC Product Approval # | Year of Original Installation or Replacement | No Information Provided for Compliance |
|---|---|---|---|---|
| <input checked="" type="checkbox"/> 2. Concrete / Clay Tile | __05__/__01__/_2014__ | _____ | _____ | <input type="checkbox"/> |

**PHOTO 1 – Roof Overview, Covering = Tile**

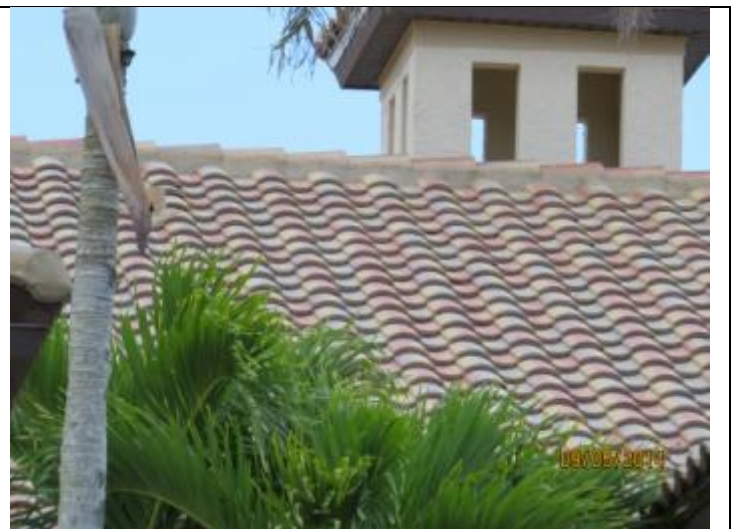
**PHOTO 2 – Roof Overview, Covering = Tile**

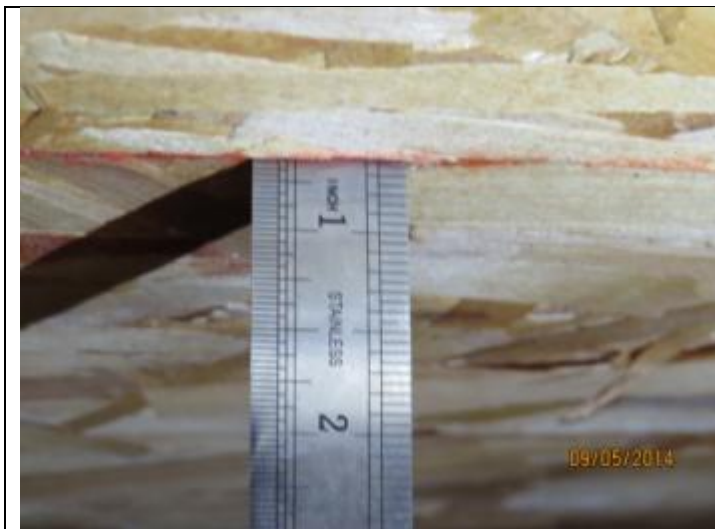
PHOTO 3 – Roof Deck = OSB

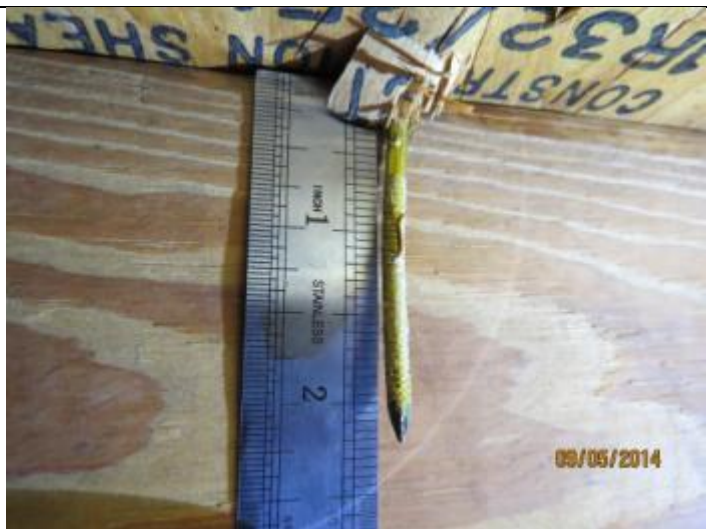
- ☒ C. Plywood/OSB roof sheathing with a minimum thickness of 7/16" inch attached to the roof truss/rafter (spaced a maximum of 24" inches o.c.) by 8d common nails spaced a maximum of 6" inches in the field. **-OR-** Dimensional lumber/Tongue & Groove decking with a minimum of 2 nails per board (or 1 nail per board if each board is equal to or less than 6 inches in width). **-OR-** Any system of screws, nails, adhesives, other deck fastening system or truss/rafter spacing that is shown to have an equivalent

PHOTO 4 – Roof Deck Attachment = 8D Nails

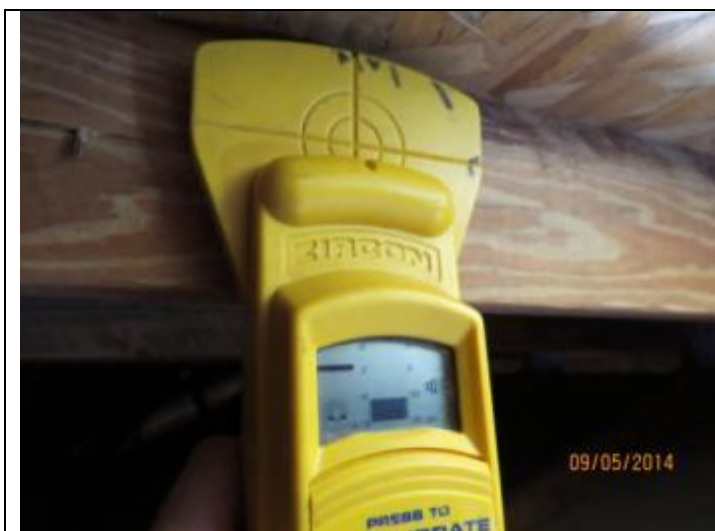
PHOTO 5 – Roof Deck Attachment Locations

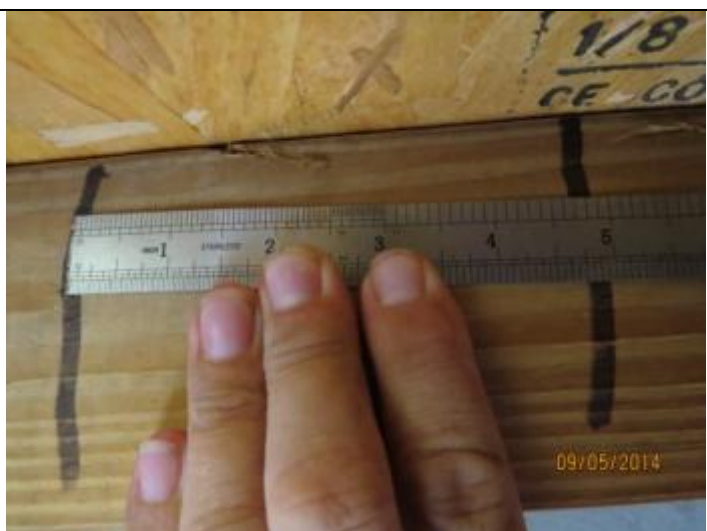
PHOTO 6 – Roof Deck Attachment Spacing

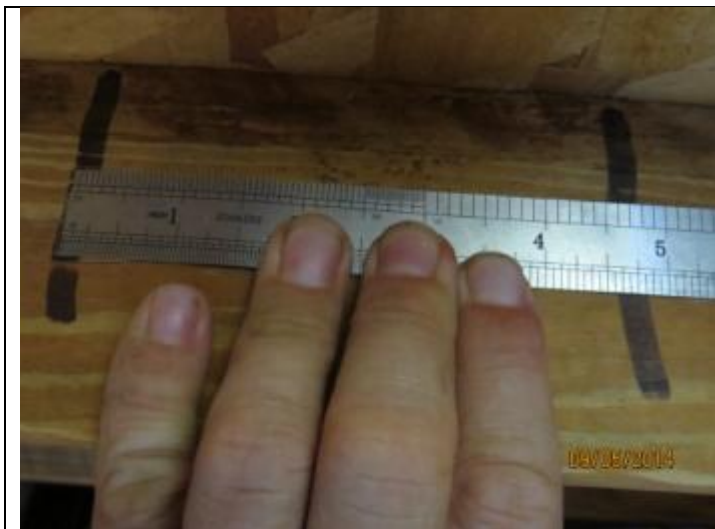
PHOTO 7 – Roof Deck Attachment Spacing

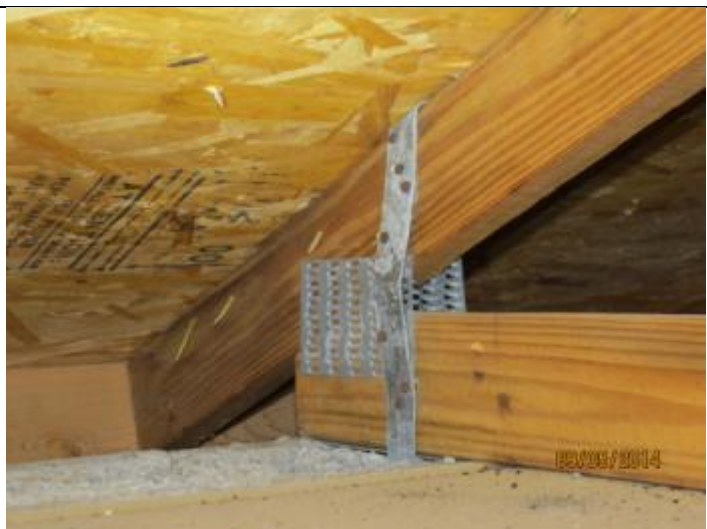
- ☒ C. Single Wraps
  - Metal connectors consisting of a single strap that wraps over the top of the truss/rafter and is secured with a minimum of 2 nails on the front side and a minimum of 1 nail on the opposing side.

PHOTO 8 – Roof To Wall Attachment = Single Wrap Straps

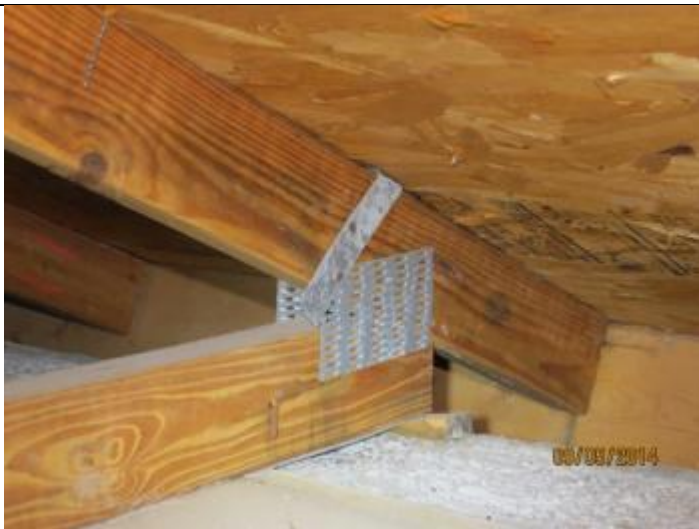
**PHOTO 9 – Roof To Wall Attachment = Single Wrap Straps**

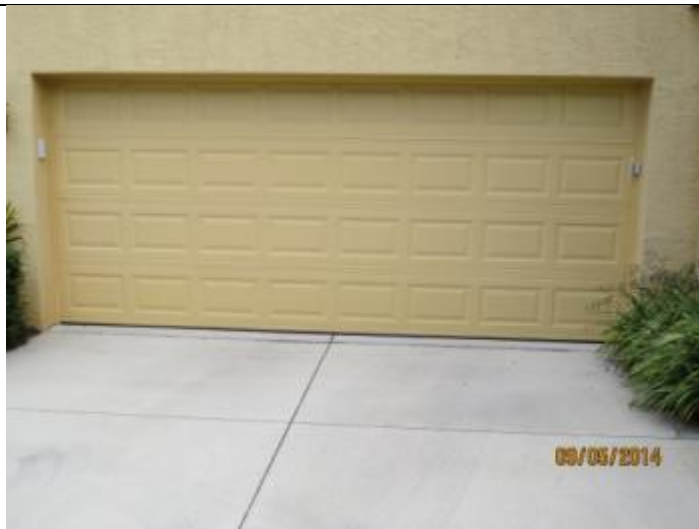
| Opening Protection Level Chart<br>Place an "X" in each row to identify all forms of protection in use for each opening type. Check only one answer below (A thru X), based on the weakest form of protection (lowest row) for any of the Glazed openings and indicate the weakest form of protection (lowest row) for Non-Glazed openings. | | Glazed Openings | | | | Non-Glazed Openings | |
|---|---|---|---|---|---|---|---|
| | Other protective coverings that cannot be identified as A, B, or C | | | | | X | X |

**PHOTO 10 – Garage Door**

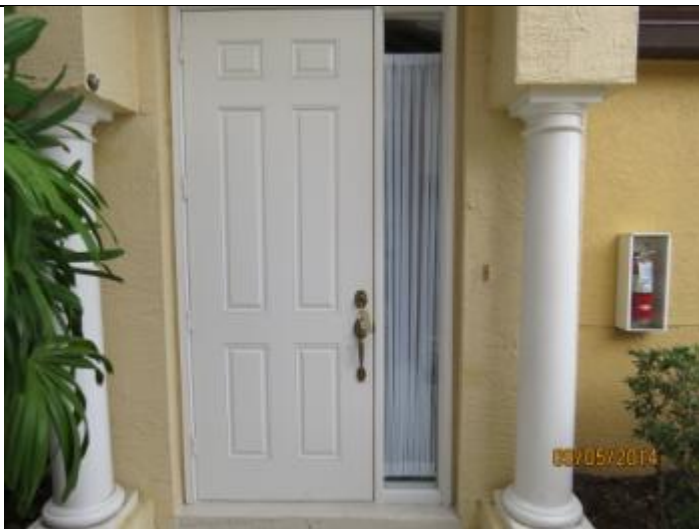
**PHOTO 11 – Entry Door**

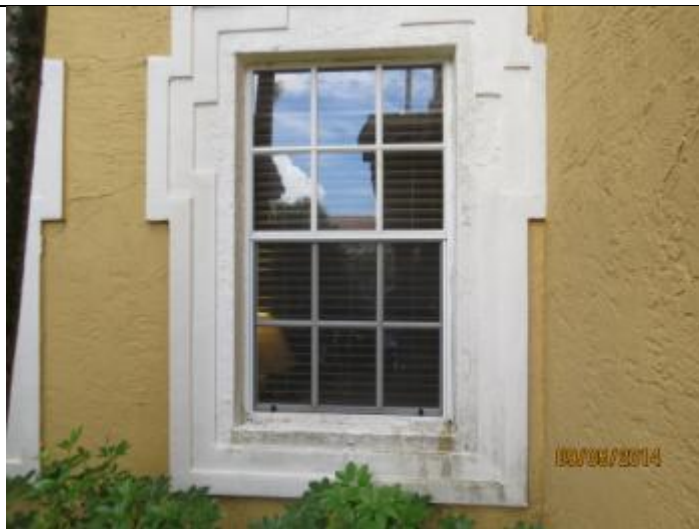
| Opening Protection Level Chart<br>Place an "X" in each row to identify all forms of protection in use for each opening type. Check only one answer below (A thru X), based on the weakest form of protection (lowest row) for any of the Glazed openings and indicate the weakest form of protection (lowest row) for Non-Glazed openings. | | Glazed Openings | | | | Non-Glazed Openings | |
|---|---|---|---|---|---|---|---|
| <b>X</b> | No Windborne Debris Protection | X | | | | | |

**PHOTO 12 - Window**

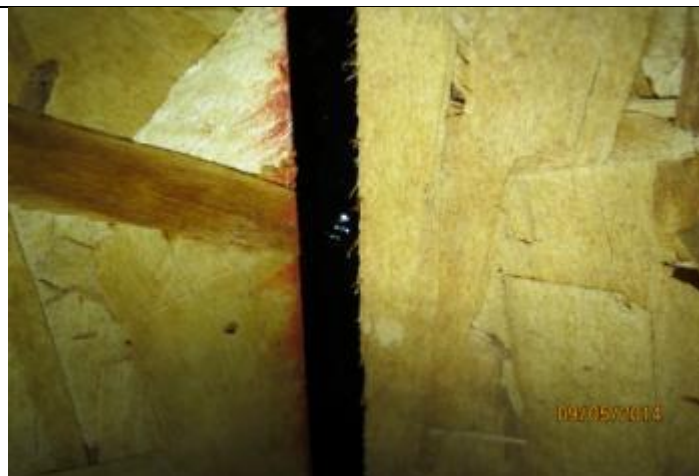
- ☒ A. SWR (also called Sealed Roof Deck) Self-adhering polymer modified-bitumen roofing underlayment applied directly to the sheathing or foam adhesive SWR barrier (not foamed-on insulation) applied as a supplemental means to protect the dwelling from water intrusion in the event of roof covering loss.
- ☐ B. No SWR
- ☐ C. Unknown or undetermined.

**PHOTO 13 - SWR**

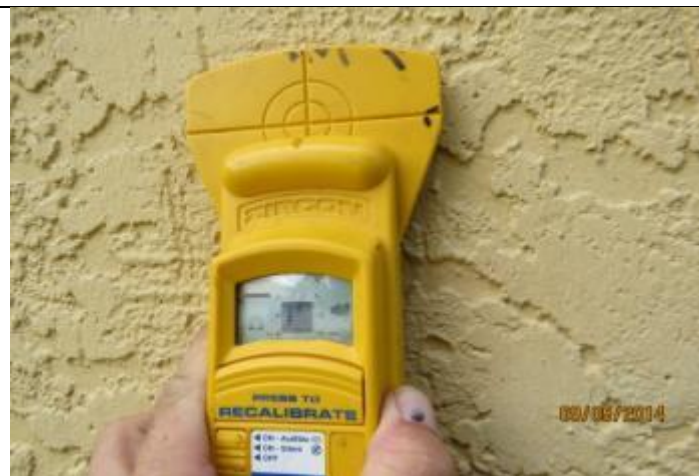
- ☐ A. Wood Frame \_\_\_\_\_ %  
☐ B. Un-Reinforced Masonry \_\_\_\_\_ %  
☒ C. Reinforced Masonry \_\_\_\_100\_\_\_\_ %  
☐ D. Poured Concrete \_\_\_\_\_ %  
☐ E. Other: \_\_\_\_\_ %

**PHOTO 14 – Exterior Walls = Reinforced Masonry**
